Tree Protection Action Key (TPAK)

**MARET SCHOOL
PROPOSED ATHLETIC FIELDS**
CORNER OF UTAH AVE NW &
NEBRASKA AVE NW
WASHINGTON, D.C. 20015

SITE UTILITY PLAN

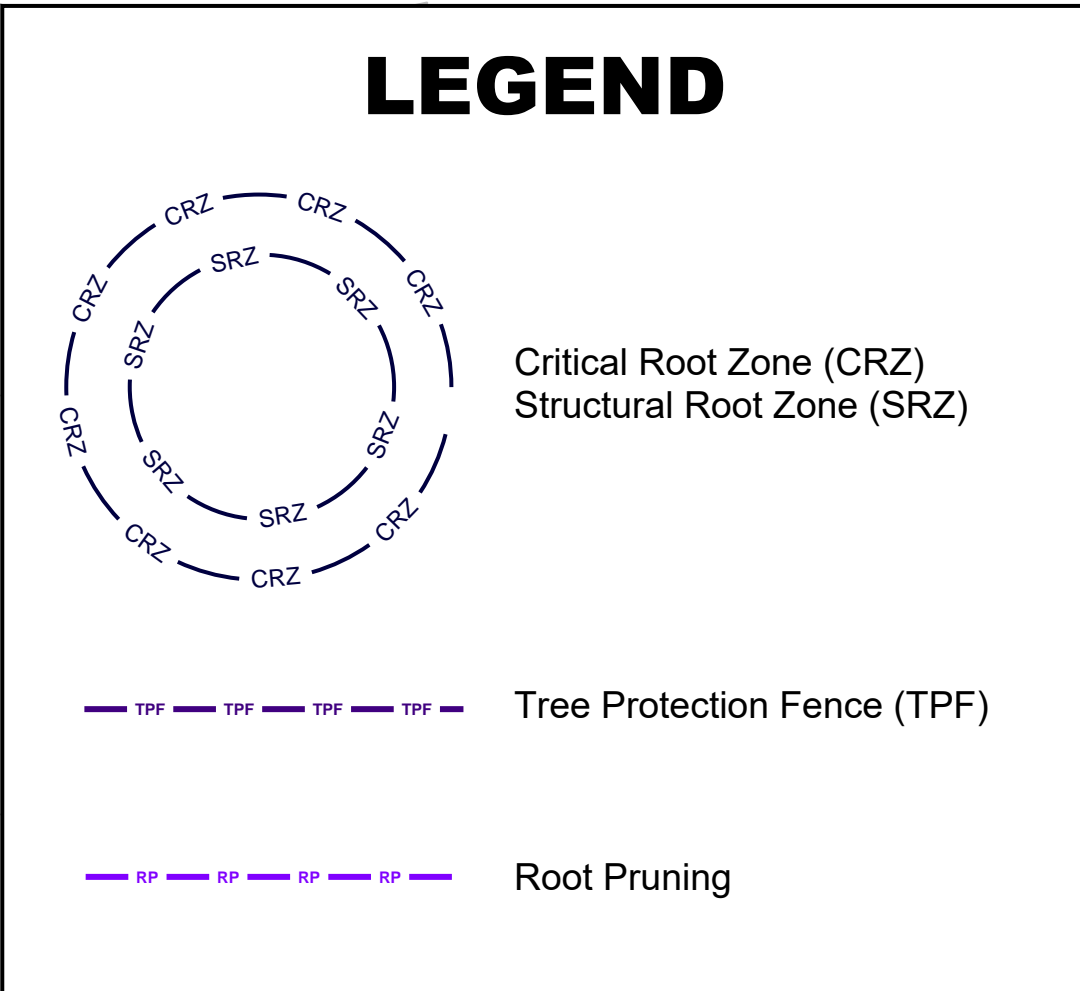
Tree #	DBH	Common Name	Botanical Name	Condition Rating	%	Condition Rating	REGULATED STATUS	SRZ	CRZ	Preservation Measures												Preservation Notes	Assessment Notes
								Structural Critical Root Zone (radius) in Feet	Critical Root Zone Radius in Ft. (1:1)	Root Prune	Mulch	Year 1 Soil Care	Year 2 Soil Care	Special Demolition	Vertical Mulching	Tree Condition Inspections	Watering	Temp Root Protection Matting	Construction Oversight/Monitoring				
323	35	pine, eastern white	Pinus strobus	80%	Good	HERITAGE	18	53	X	X	X	X	X	X	X	X	X	X	Special demolition of ex. pavement. Vertical mulch and decompact. SSAT excavation for base course of new pavement. Structural soil.	Mechanical Damage, Broken Limbs			
348	38	maple, red	Acer rubrum	50%	Fair	HERITAGE	19	57	X	X	X	X	X	X	X	X	X	X	Root-friendly curb design within CRZ. Excavation for pavement base course by arborist with SSAT.	Surface Roots, Root Damage/Decay, Co-Dominant Stems, Small DW (1-2"). Low Vigor, Broken Limbs, Branch Decay, Insect/Disease Problem, Fungal Fruiting Bodies DBH @ 2 ft. Possible soft rot fungus on large branch. Tar spot fungus. Mower damage/root decay on downhill side.

TREE PROTECTION CHECKLIST									
DATE	JOB	CONTRACTOR	NOTES	OK'd					
	Pre-construction meeting								
	Install tree protection fencing*								
	Root pruning*								
	Mulch application								
	Special demolition* (Tree 323)								
	SSAT excavation*
